Acme Manufacturing

Hot Connect.isi

Image Path	E:\INFRARED SOLUTIONS\SNAPVIEWPRO2\SAMPLE IMAGES\Hot Connect.isi
Image Date/Time	Wednesday, December 16, 1998 2:25:25 PM
Report Date/Time	Monday, July 26, 1999 12:35:09 PM
Temp Unit	Fahrenheit
User	PM Supervisor K. Esterby
Location	Acme Manufacturing
Target	Connector 3516

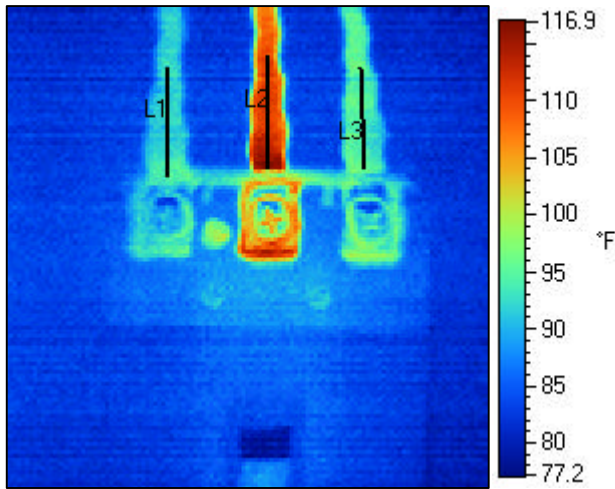
Label	Emissivity	Background	Average	Std Dev	Max	Min
L1	0.97	76.96	92.6	1.31	95.2	90.4
L2	0.97	76.96	111.6	3.07	116.9	100.1
L3	0.97	76.96	94.7	0.83	96.6	92.5

- Bi-monthly route of electrical connectors
- 2nd connection point found 20 degrees hotter than adjacent connections
- Referred to electrical department manager for immediate repair
- Tighten connection and re-image
- Add to next week's route
